Damage from  
the Tohoku-Pacific Ocean Earthquake  
and future prospects

March 30, 2011

Nippon Telegraph and Telephone East Corporation

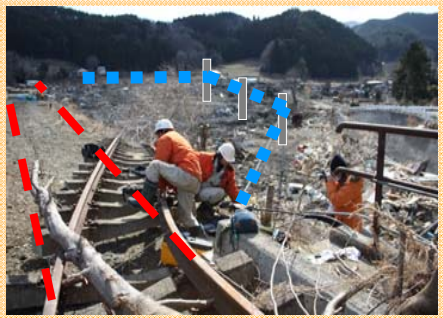
Connection of the core cabling between the existing cable and the backup relay route cable.

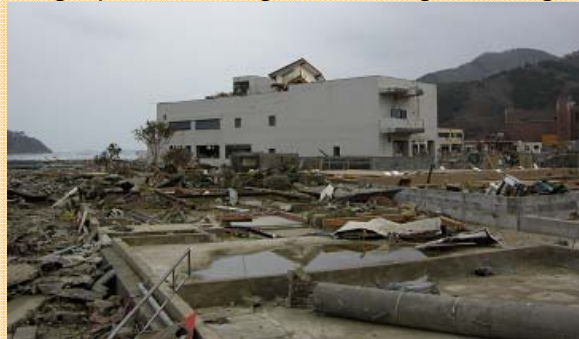
The tsunami greatly damaged the building and flooded the surrounding area

■ Since the Onagawa Building was flooded and damaged, service is scheduled to be restored by mid-next week through the installation of a RSBM-F (outdoor use circuit switch) in the Onagawa Town Disaster Countermeasures Headquarters, and establishing a connection to the Watanoha Building, which is located at a higher layer within the telecommunication network.

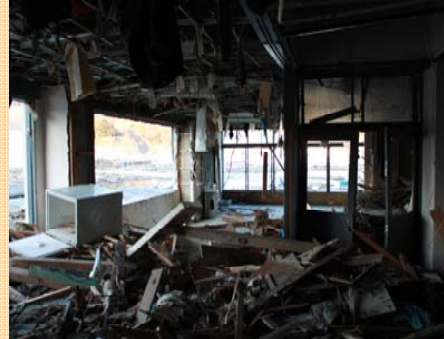
Walls were damaged and the building was filled with driftage

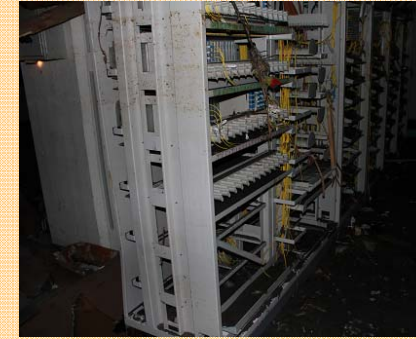
Communication equipment was also damaged by the flooding

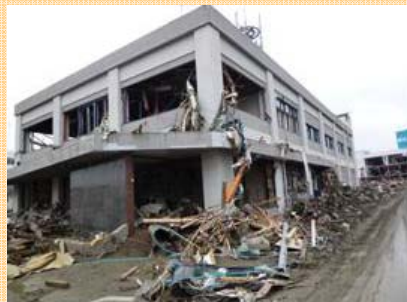
The tsunami greatly damaged the building and flooded the surrounding area

■ Since the Rikuzen-Takata Building is not functioning due to damage from the tsunami, circuits originally situated in this building will be switched to a PSTN circuit switch located in neighboring exchange building for the restoration of services by mid-next week

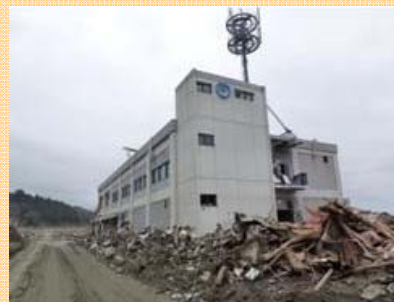
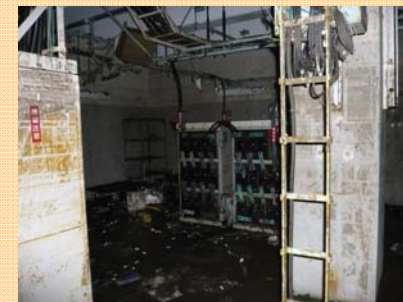
Power equipment was also greatly damaged from the flooding
