Tohoku – Pacific Ocean Earthquake: Current Status and Restoration Plan

NTT DOCOMO, INC.

March 30, 2011

Damage to Base Stations & Restoration Measures

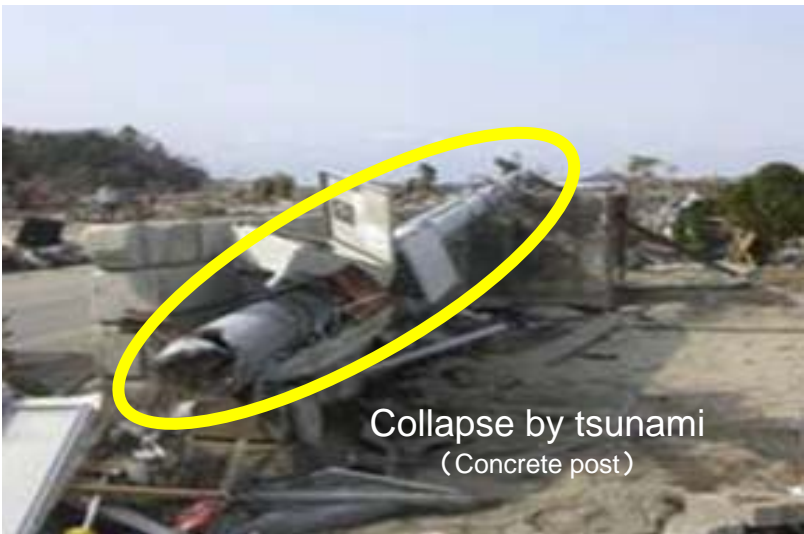
1. Base station facility (Matsuhima-Nobiru, Miyagi)

Collapse by tsunami
(Concrete post)

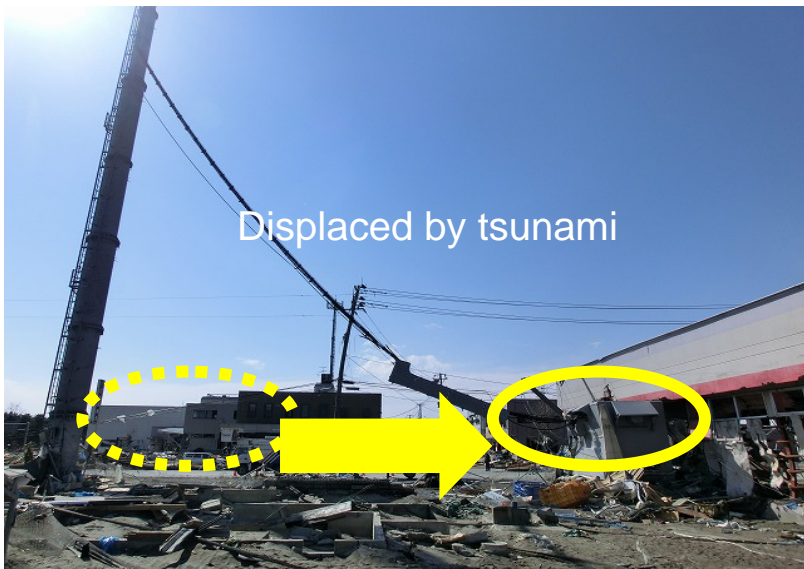
3. Base station facility (Ishinomaki-Midori-cho, Miyagi)

Displaced by tsunami
